Manhole Inspection Summary

Manhole # S35C__023MH

Insp Date: **8/5/08 11:22 AM**

Location Address: **rear 315 n charles st**

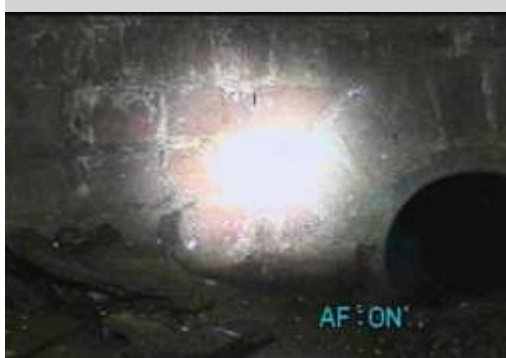
Miscellaneous

channel debris

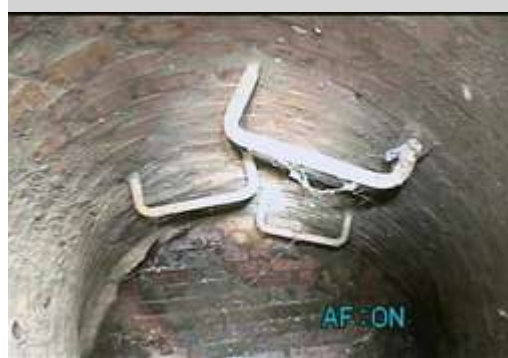
Defect 1

Steps Count: **3** Missing: **0** ☒ **Corroded**

corroded steps

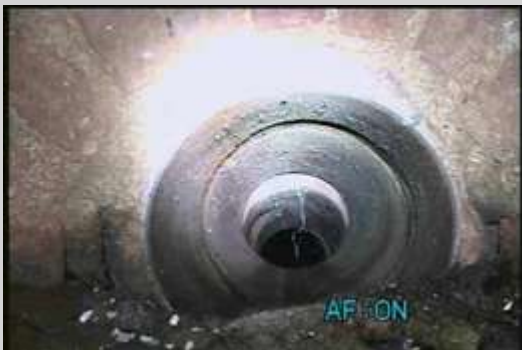
12 O'Clock Outflow

8 in. Circular Gravity Sewer
Pipe Out @ 12 O'Clock

Pipe Material: **Clay** ☐ Pipe Lined

Invert Depth: 7.41 (ft.) Flow Characteristics: **None**

Infiltration: **None** Pipe Seal Cond: **Unknown**

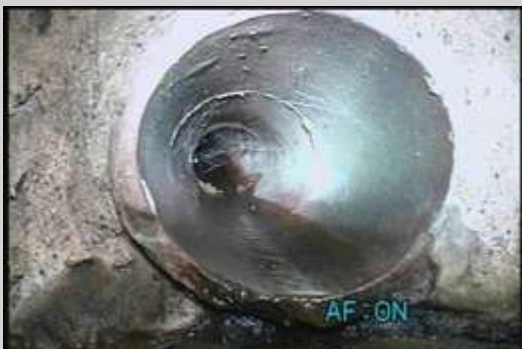
7 O'Clock Inflow

8 in. Circular Gravity Sewer
Pipe In @ 7 O'Clock

Pipe Material: **Clay** ☐ Pipe Lined

Invert Depth: 6.75 (ft.) Flow Characteristics: **None**

Infiltration: **None** Pipe Seal Cond: **Unknown**
